Practical aspects of environmental assessment of water bodies transformation

Keywords: European Union Water Framework Directive; Danube River Basin; surface water body; risk criteria; hydromorphological assessment

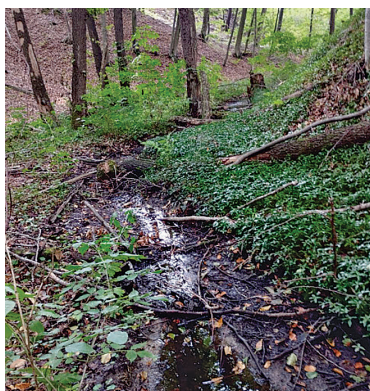
The channel of the studied water body is a low-flowing channel with a catchment area of 0.3 km². Its width ranges from 0.5 m to 1.5 m, depth from 0.02 m to 0.05 m, and average width is 0.8 m. The channel of the water body is composed of silt and clay with the remains of trees. Artificial ponds have been constructed here, which contributed to the change of the stream channel. Its floodplain is weakly defined with natural vegetation (Fig. 2). The constructed hydraulic structures on the ponds, which are more than 1 m high, are silted up, and therefore have a negative impact on the continuity of the stream flow, impeding the migration of aquatic life and the transport of suspended sediments.

Figure 2. Unnamed stream (Karapchiv village)
Source: photo materials from field research

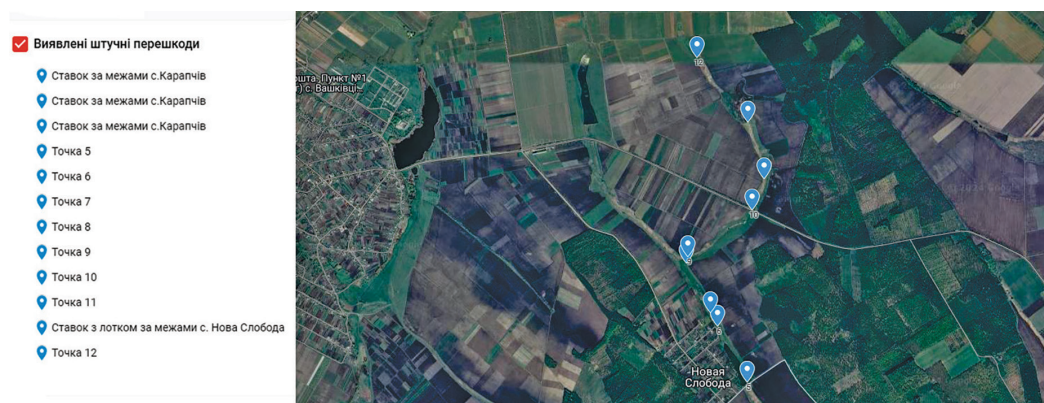
Figure 5. Geographical reference of 9 survey points for detection of artificial structures outside Nova Sloboda village

sub-basin, Danube basin), was carried out (Fig. 5). The channel of the unnamed stream in the village of Nova Sloboda was winding and overgrown. Its width ranged from 2.0 m to 4.0 m. It is composed of silt and clay. The channel dries up in the low water period. The floodplain of the stream is low, overgrown with bushes and grass (Fig. 6).

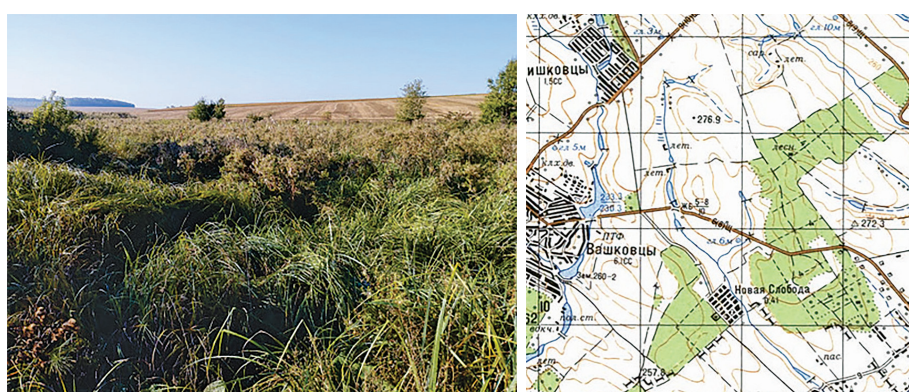
Figure 6. Unnamed stream (overgrown), (Nova Sloboda village)

The water body under study has undergone significant anthropogenic impact due to the construction of artificial ponds in the channel. Hydraulic structures on the ponds are silted up, and therefore they are an obstacle that affects the continuity of the stream, the nature of
